तलाईपाली / Talaipalli

Sub: Environment Statement (Form V) for the year 2020-21 of NTPC Ltd., Talaipalli Coal Mine Project.

[FORM-V] (See Rule 14, E(P) Rules 1986) Environment Statement for the financial year 2020-2021ending 31st March 2021

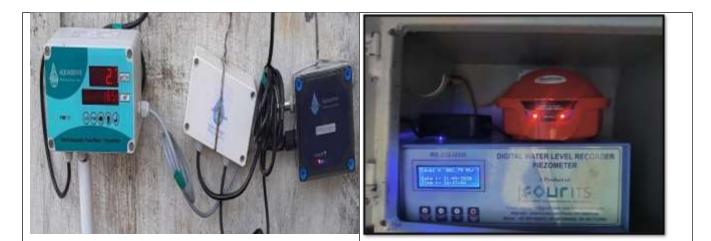
Installation of Piezometers

- Water sprinkling through mobile water tankers for mines dispatch road, haul road dust suppression.
- 11 Recharge Pond structures has been implemented at Naya Rampur ponds to increase the water table.
- ↓ Dust extraction and wetting process are being used for drilling process
- Plantation in Site office areas, mine boundary, Nearby Villages, viewpoint areas and dump areas
- **4** Grass seeds stowing over Topsoil dumps for better stabilization and soil fertility conservation.
- 4 Check-dam near Naya Rampur nallah for silt control in surface run-off from mines area.
- 4 2 piezometers have been installed to give online continuous data of ground water level.
